United States
Circuit Court of Appeals
For the Ninth Circuit.

UNITED STATES OF AMERICA,
Appellant,

J. LESLIE MORRIS COMPANY, INC., a cor-
poration,
Appellee.

Transcript of Record
(Plaintiff's Exhibits 1 to 32)

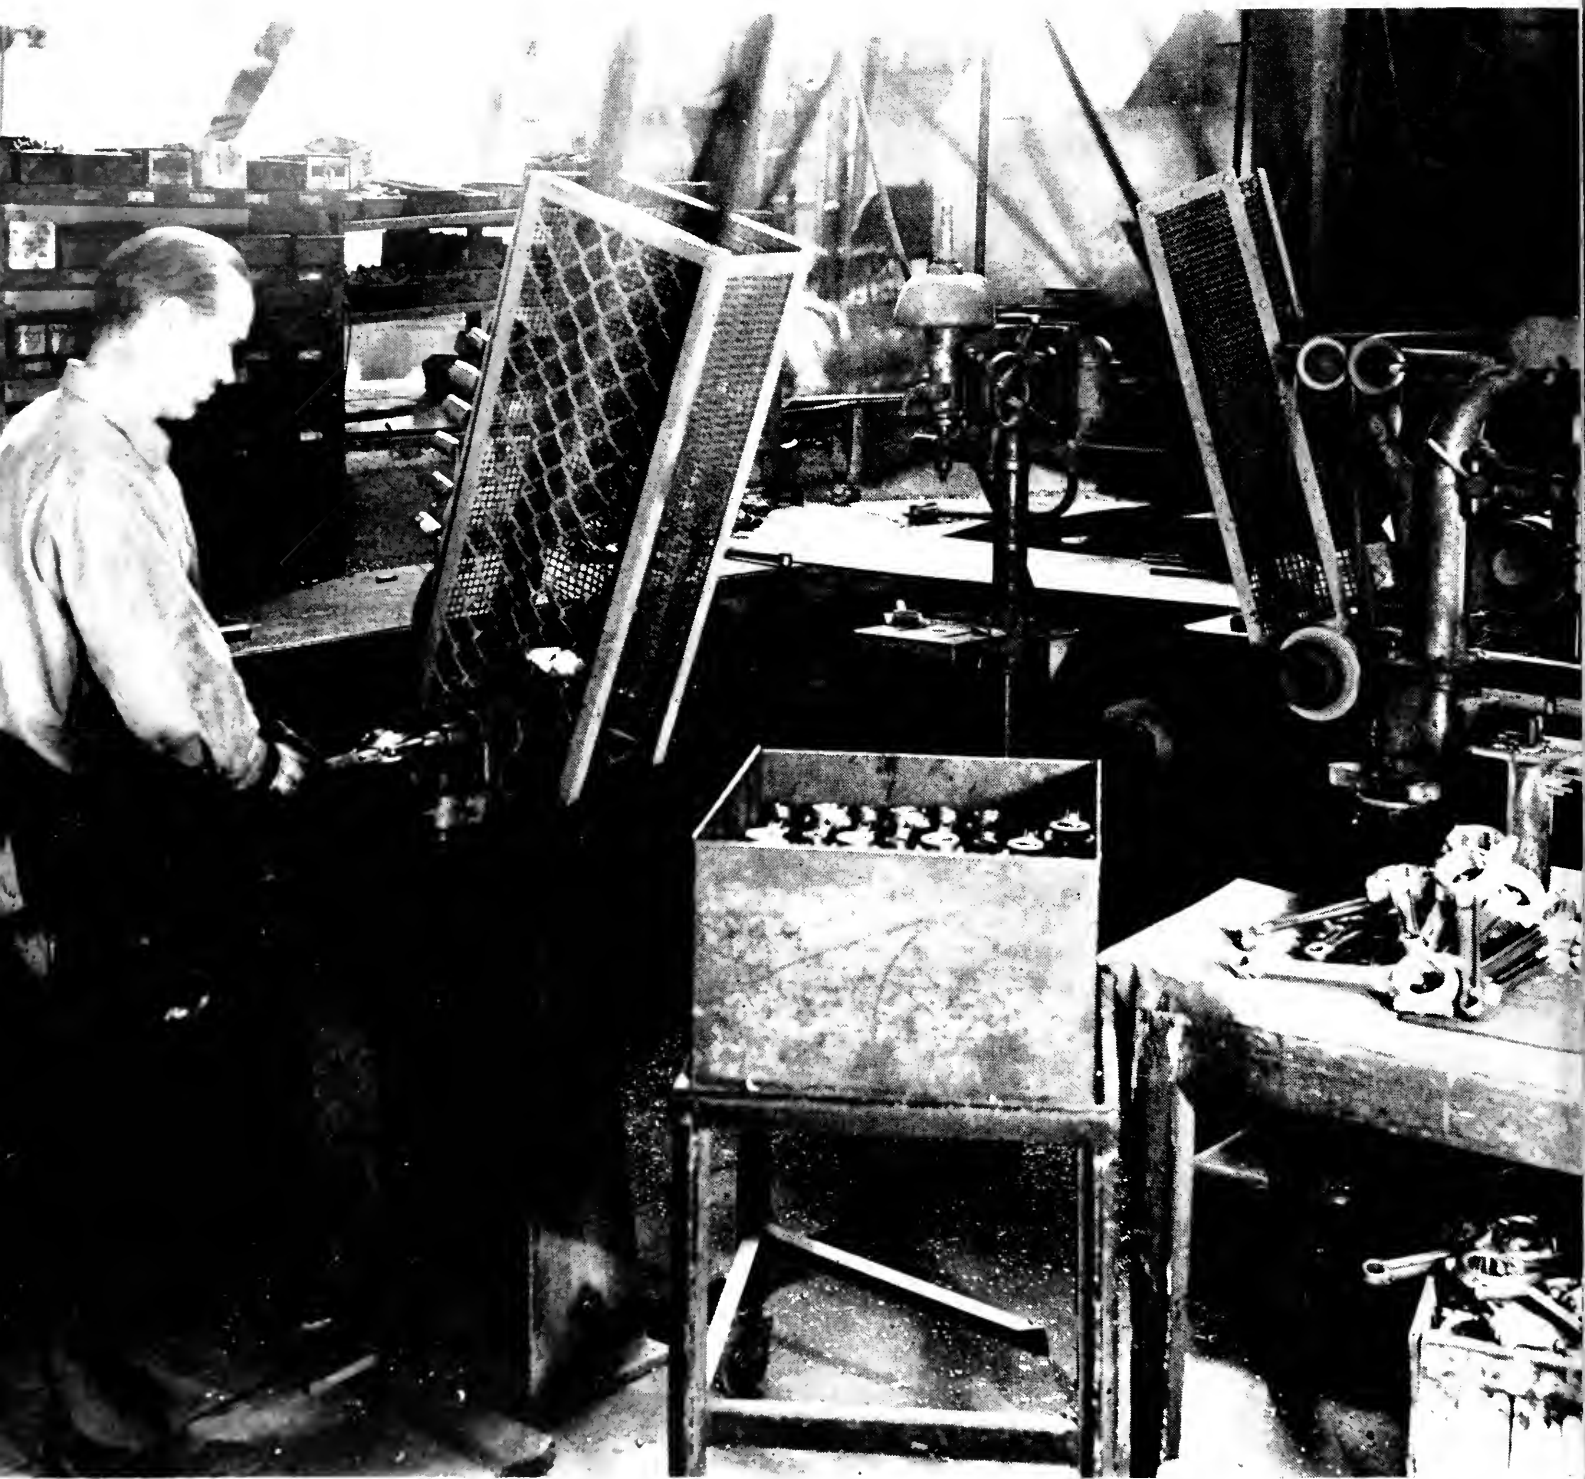
PLAINTIFF'S EXHIBIT No. 17

The cap is replaced on the rod using the original bolts and nuts, the removal of which was described in Picture 5. A power driven socket wrench is used in performing this operation.

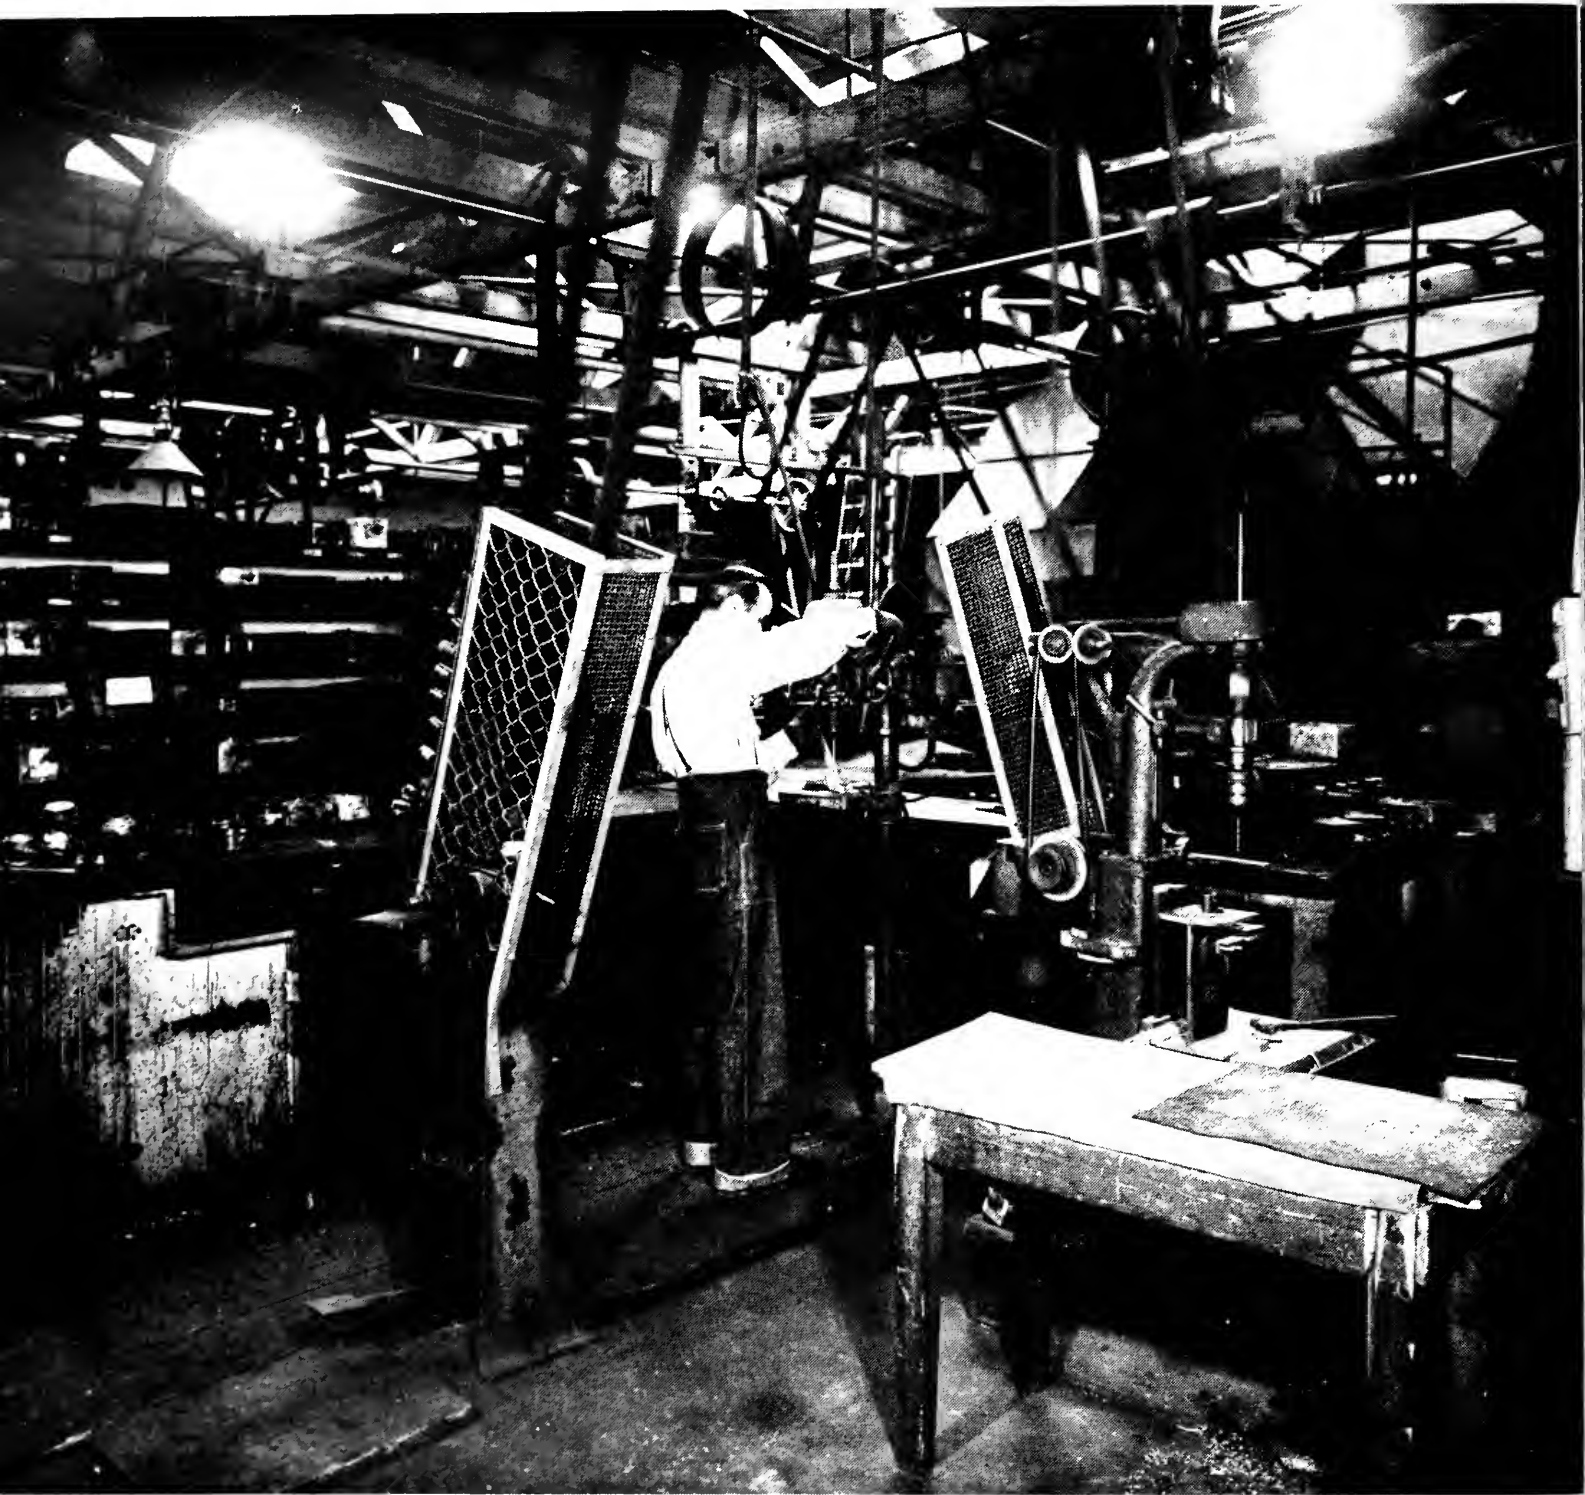
PLAINTIFF'S EXHIBIT No. 18

The operator cleans out the oil holes by use of a drill press as shown in this picture.

The oil holes are not always the same size. Accordingly, the operator uses a second drill press with a larger drill to perform the same operation shown in Picture 18. This removes the necessity for frequently changing drills.

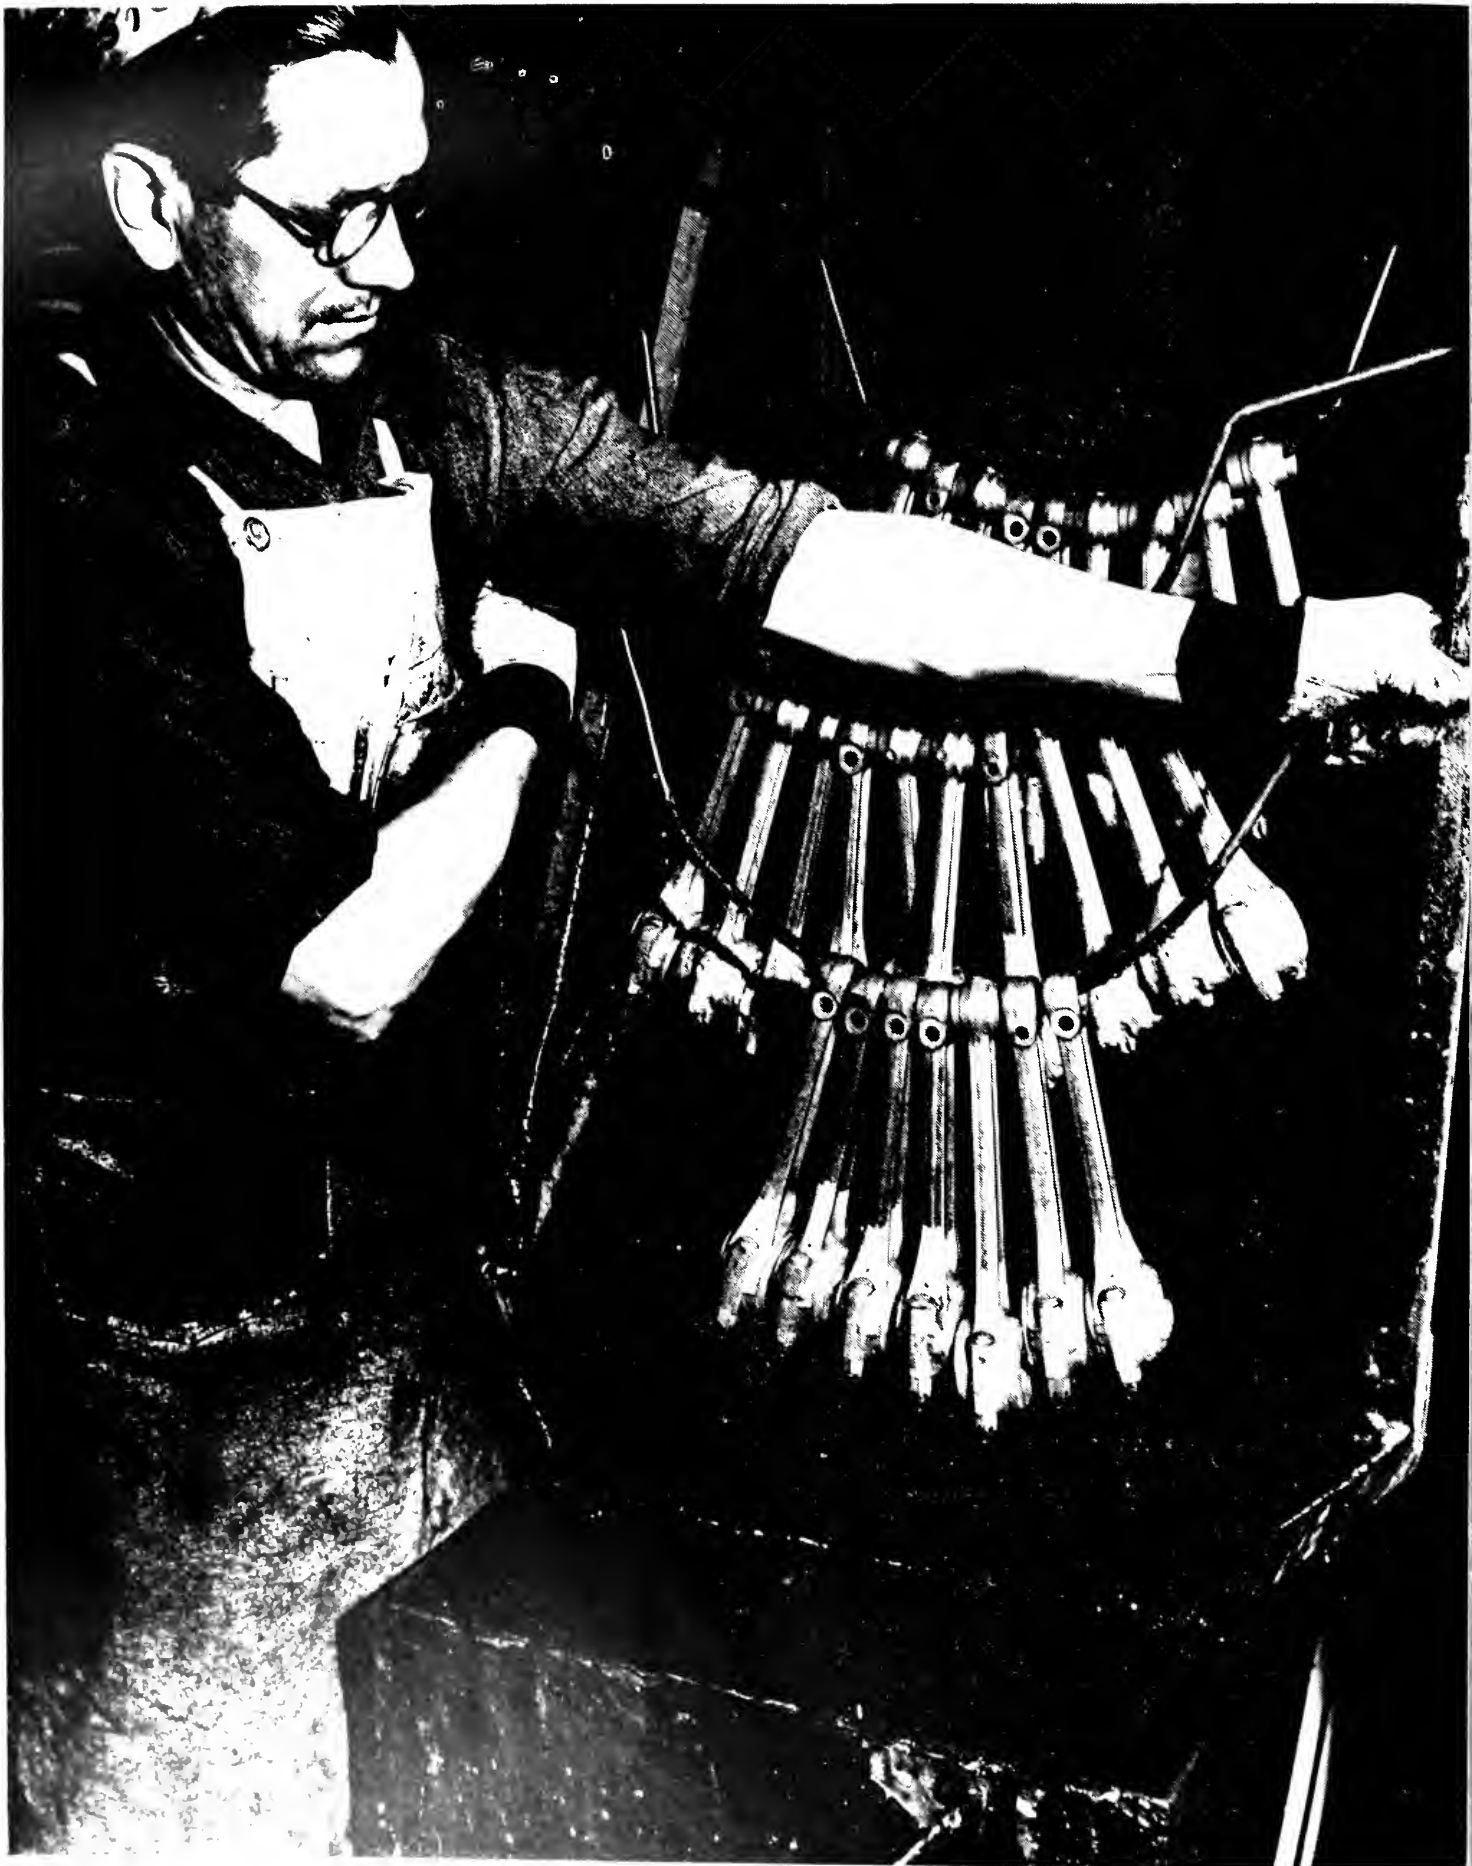
PLAINTIFF'S EXHIBIT No. 20

The rods are now dipped in a rust preventative and are then hung on a rack to dry,—as shown in above picture.

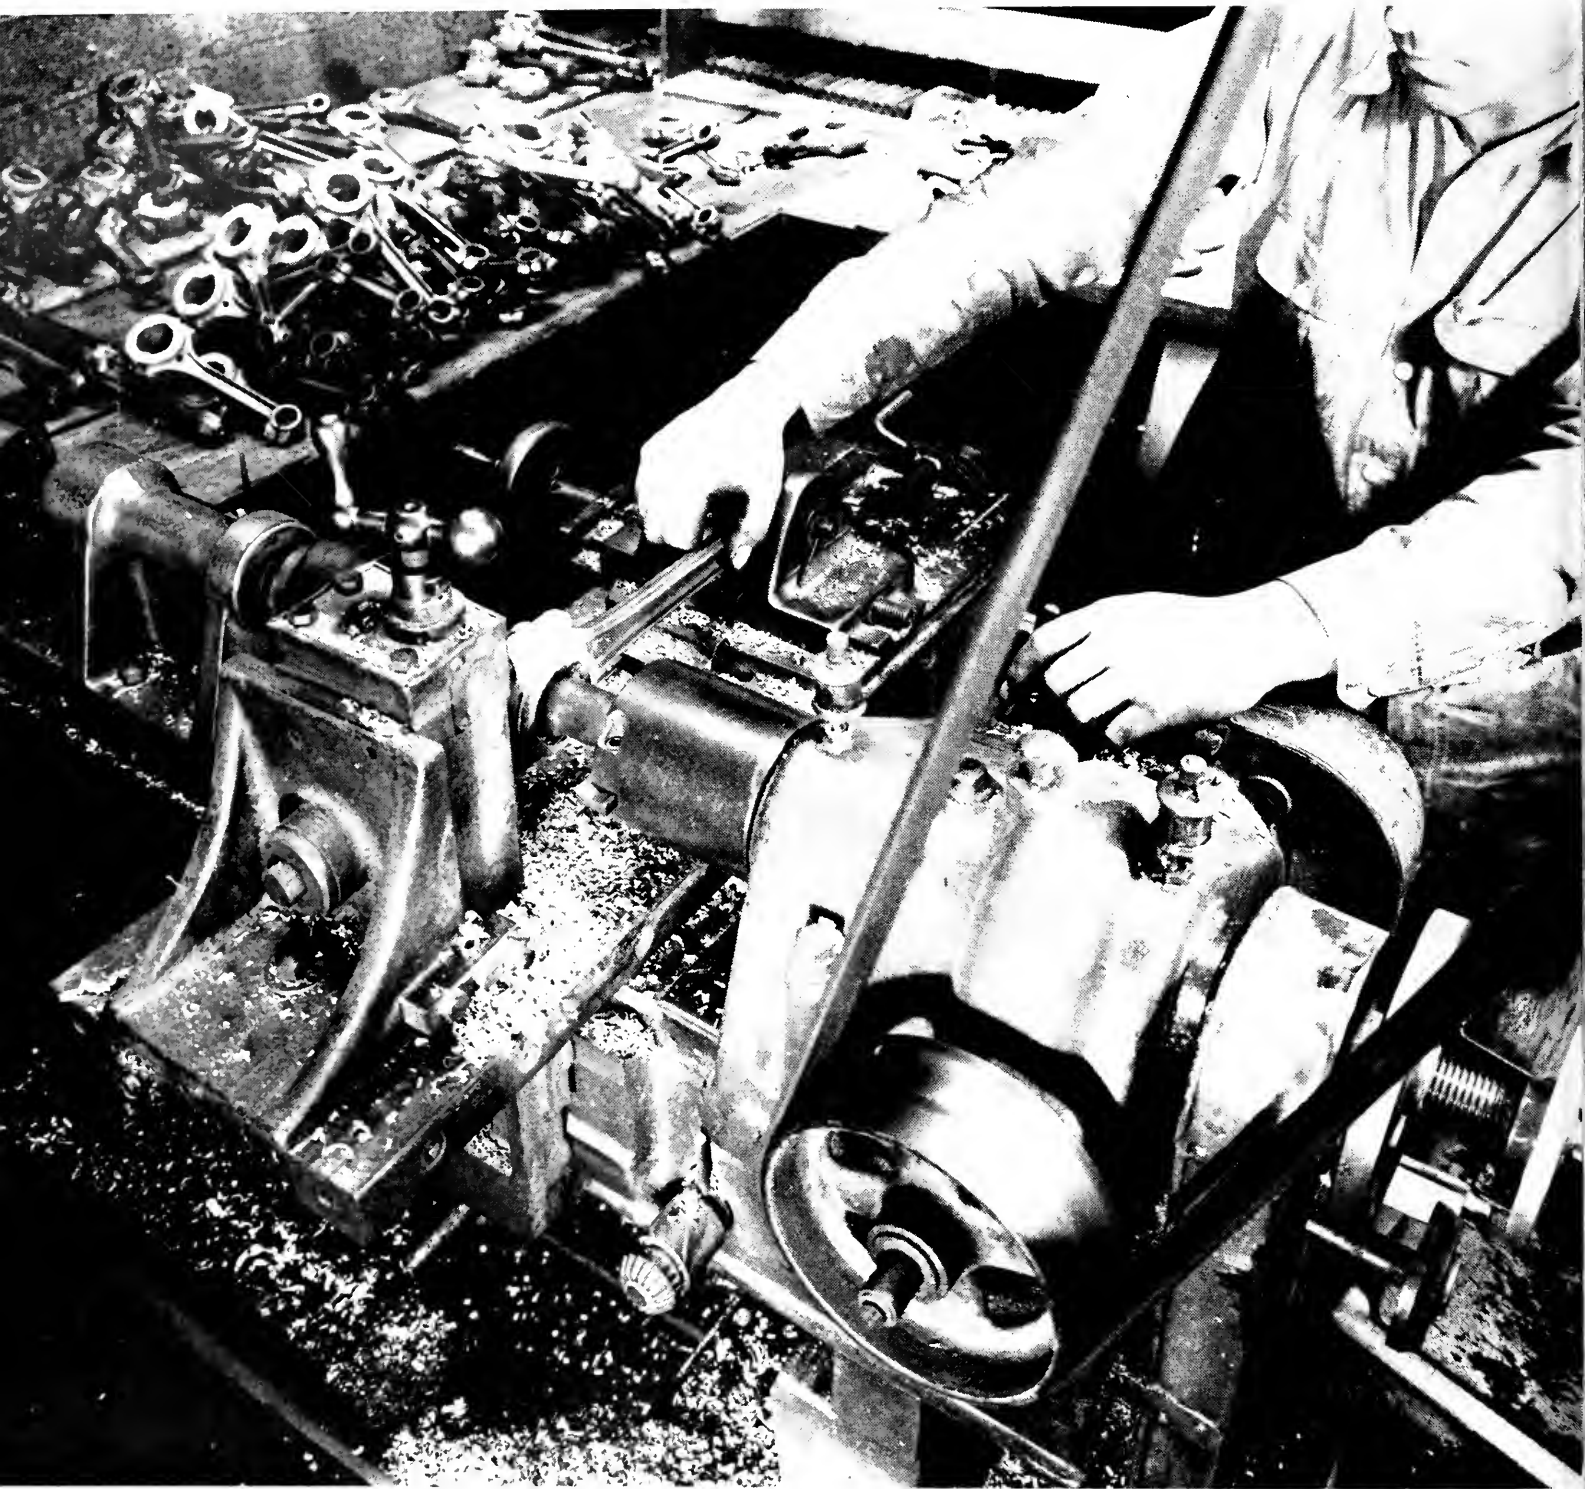
PLAINTIFF'S EXHIBIT No. 21

The rod is now placed in a lathe and the babbitt is bored, faced and chamfered. The latter two operations finishes the bearing to standard width.

The lathe used in the above picture is identical with the one shown in Picture 21, however it is used for finishing babbitt bearings to special undersizes as ordered by the customer. About 20% of the connecting rods rebabbitted by the plaintiff are bored to special undersizes for the reason that the crankshafts of the automobiles in which they are to be placed have been reground in order to correct for the wear which has resulted from long operation.

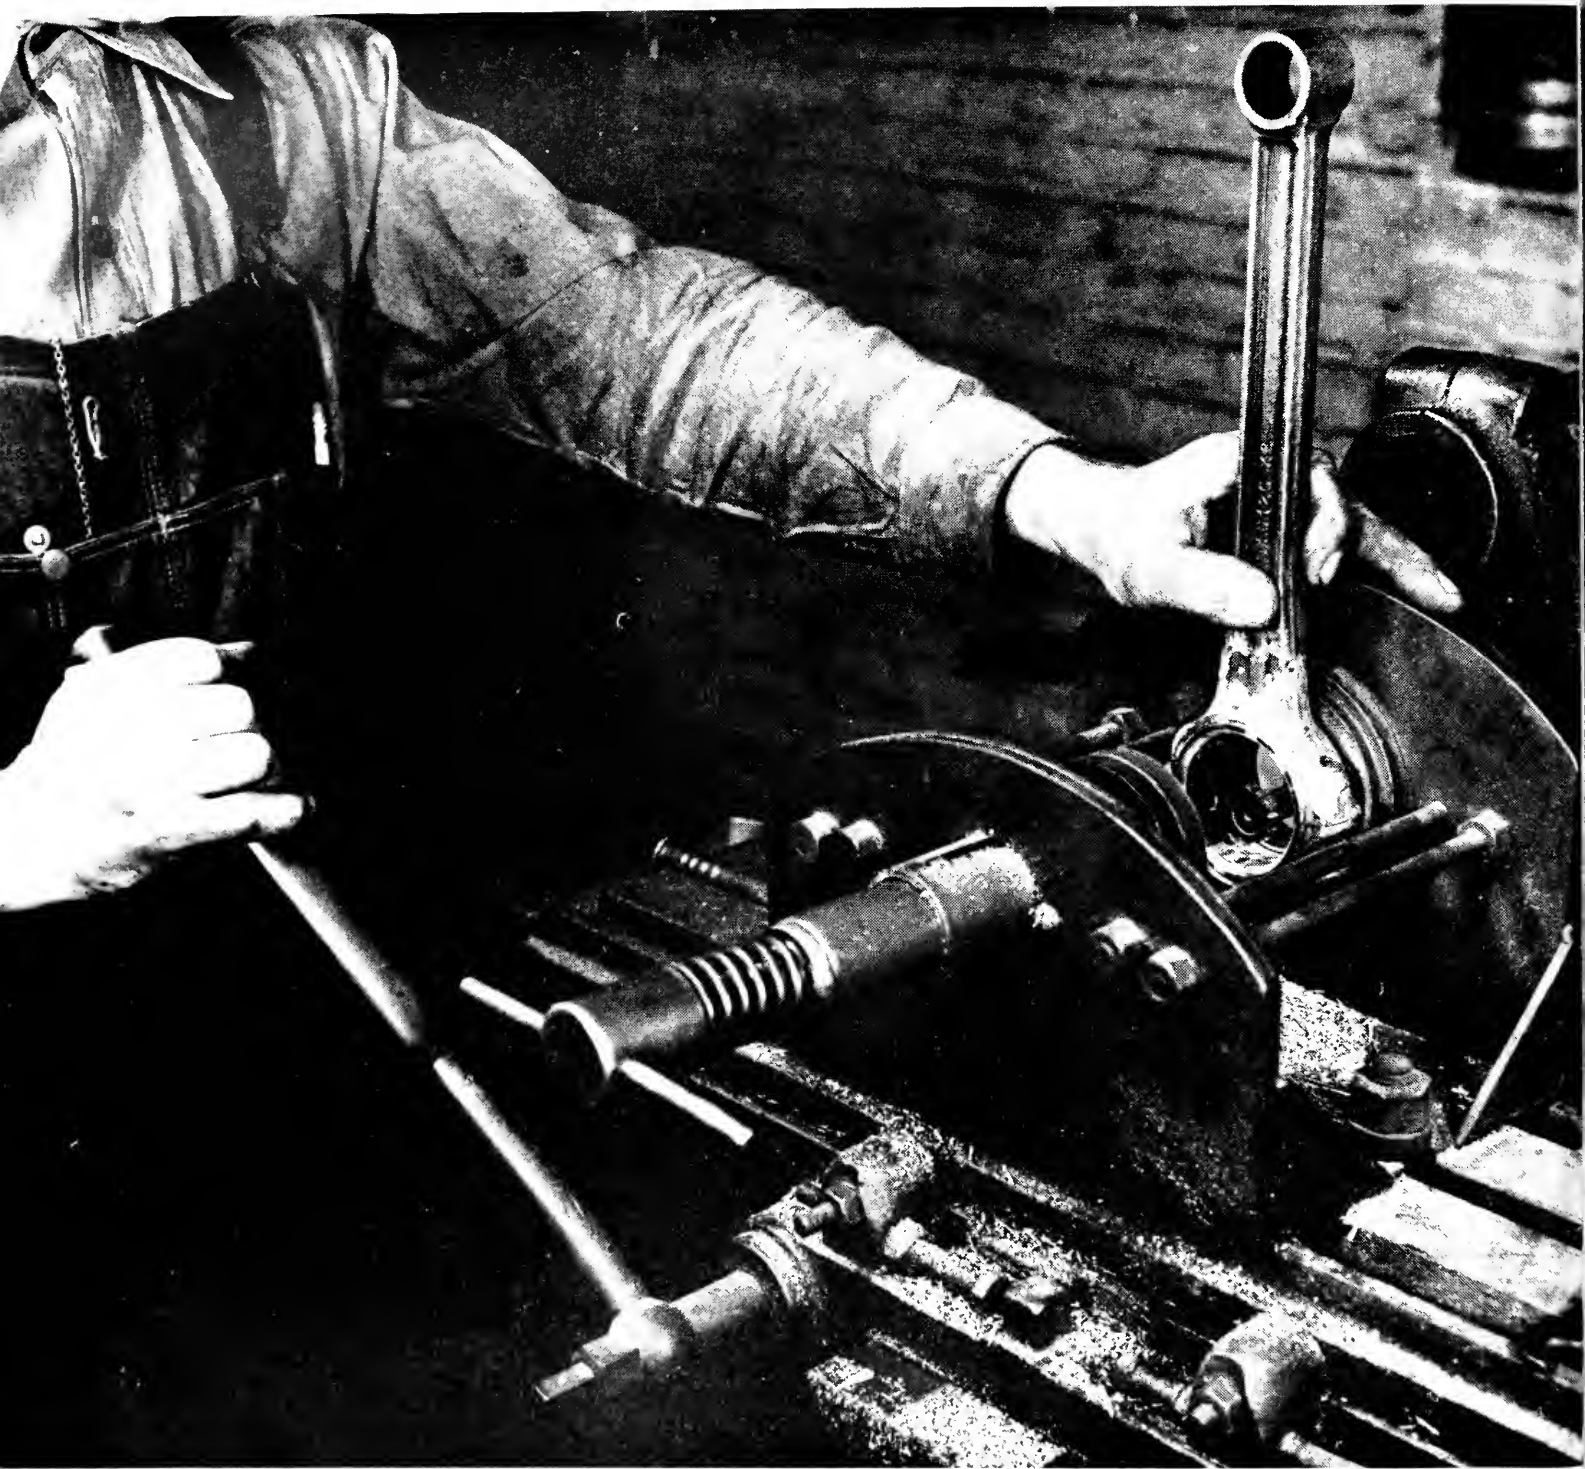
PLAINTIFF'S EXHIBIT No. 23

Approximately fifty per cent of the bearings have oil pockets which are cut by a hand milling machine as shown in the above picture.

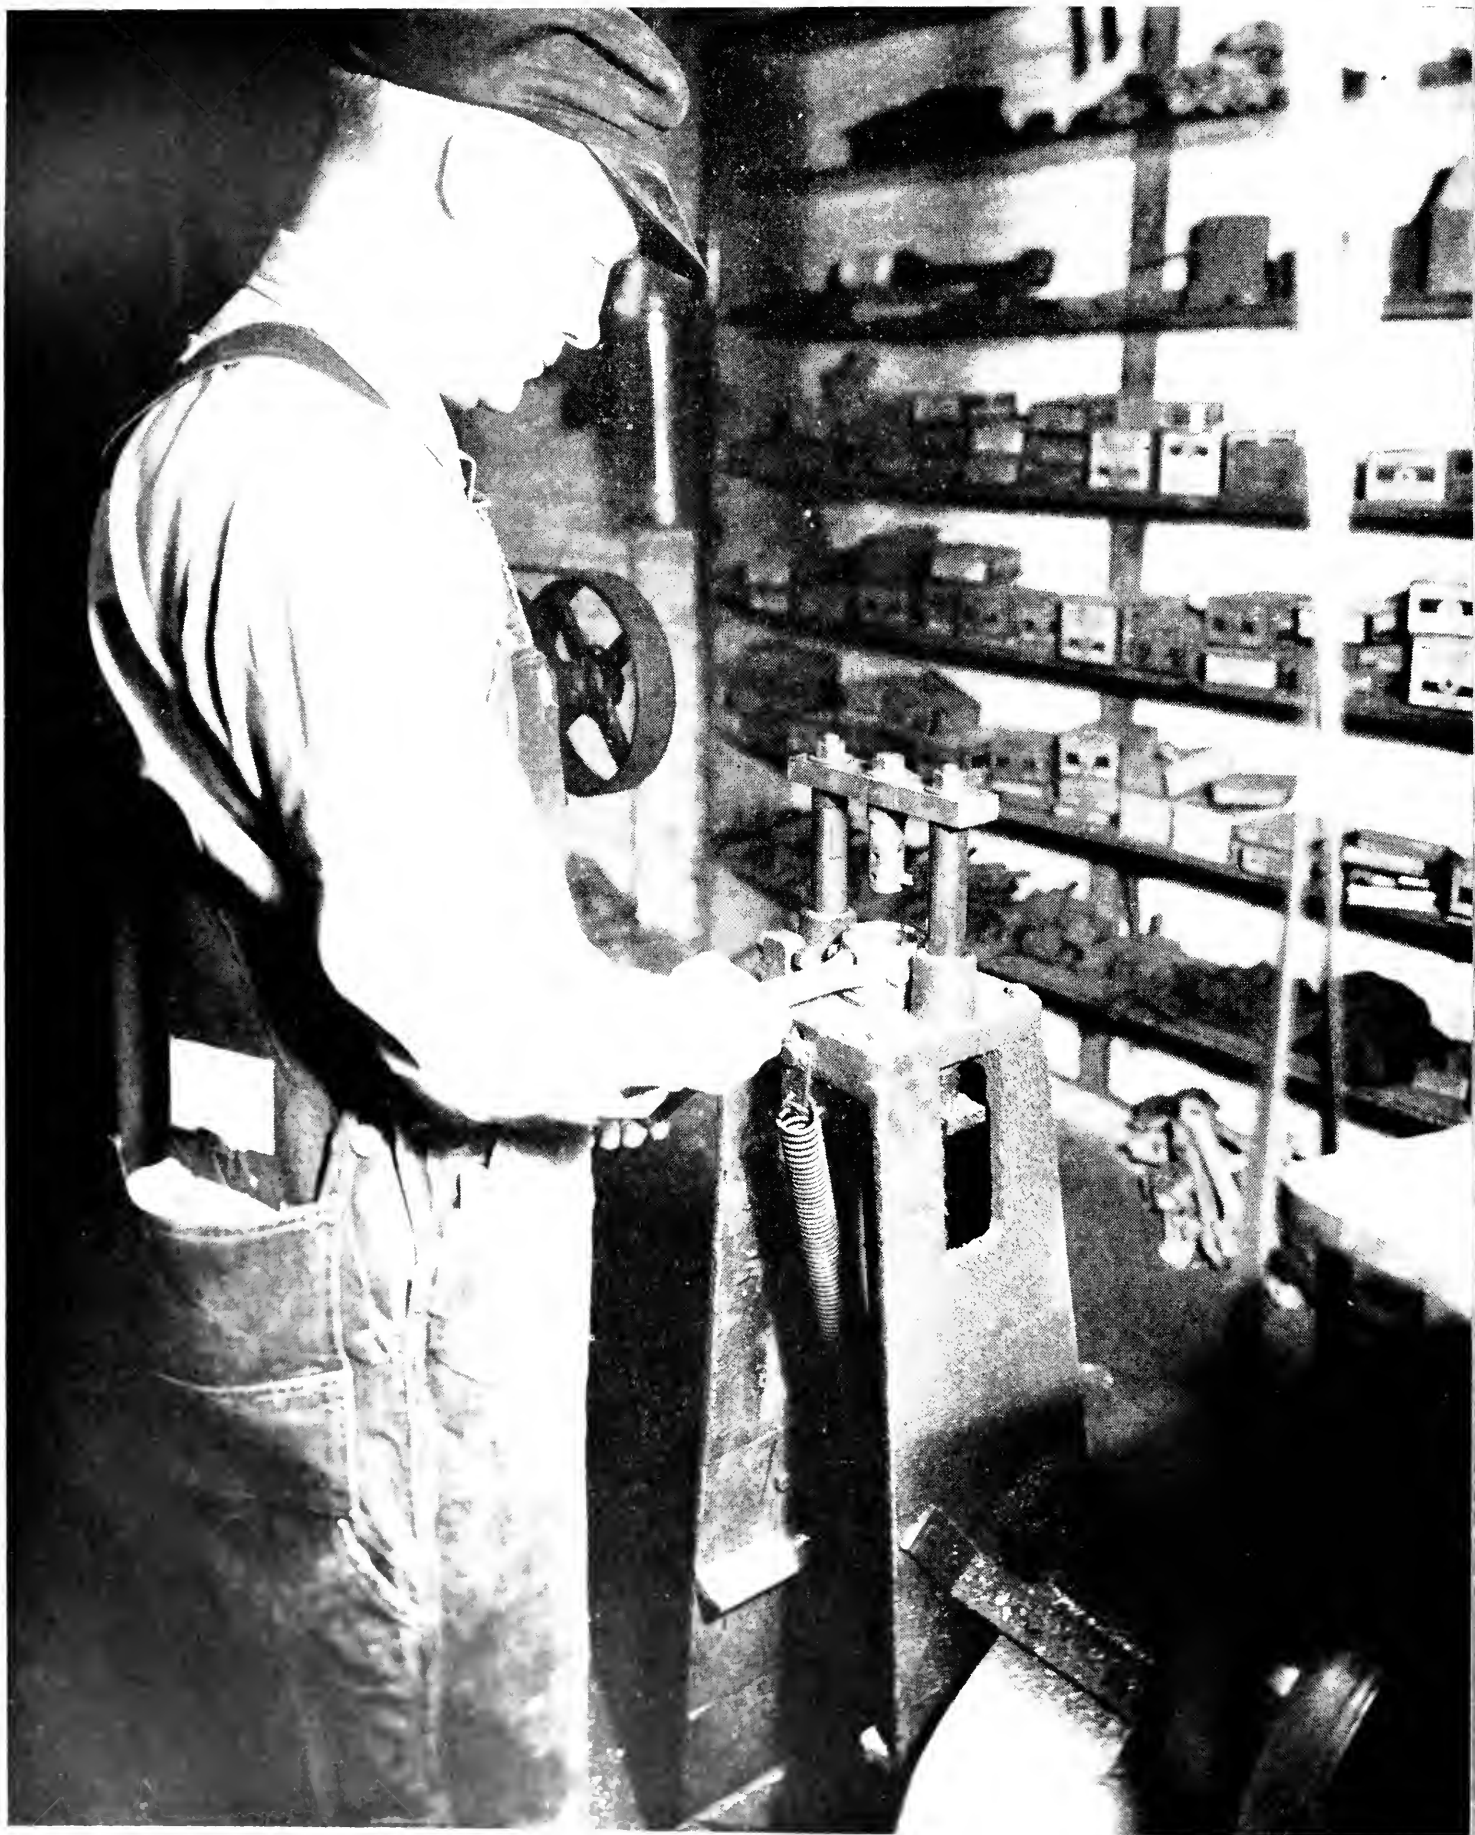
PLAINTIFF'S EXHIBIT No. 24

On Model A Ford connecting rods in which the babbitt was cast without the use of separator shims, it is necessary to cut the babbitt through the center of the bearing in order to free the cap from the shank. This operation also leaves an oil groove or relief which facilitates lubrication. This operation is performed by a slotting tool as shown in the above picture.

The Model A connecting rods are now on a saw table in which a rotating saw blade cuts the babbitt flange to complete the separating operation as shown in Picture 24. This also cuts the necessary oil relief groove through the flange.

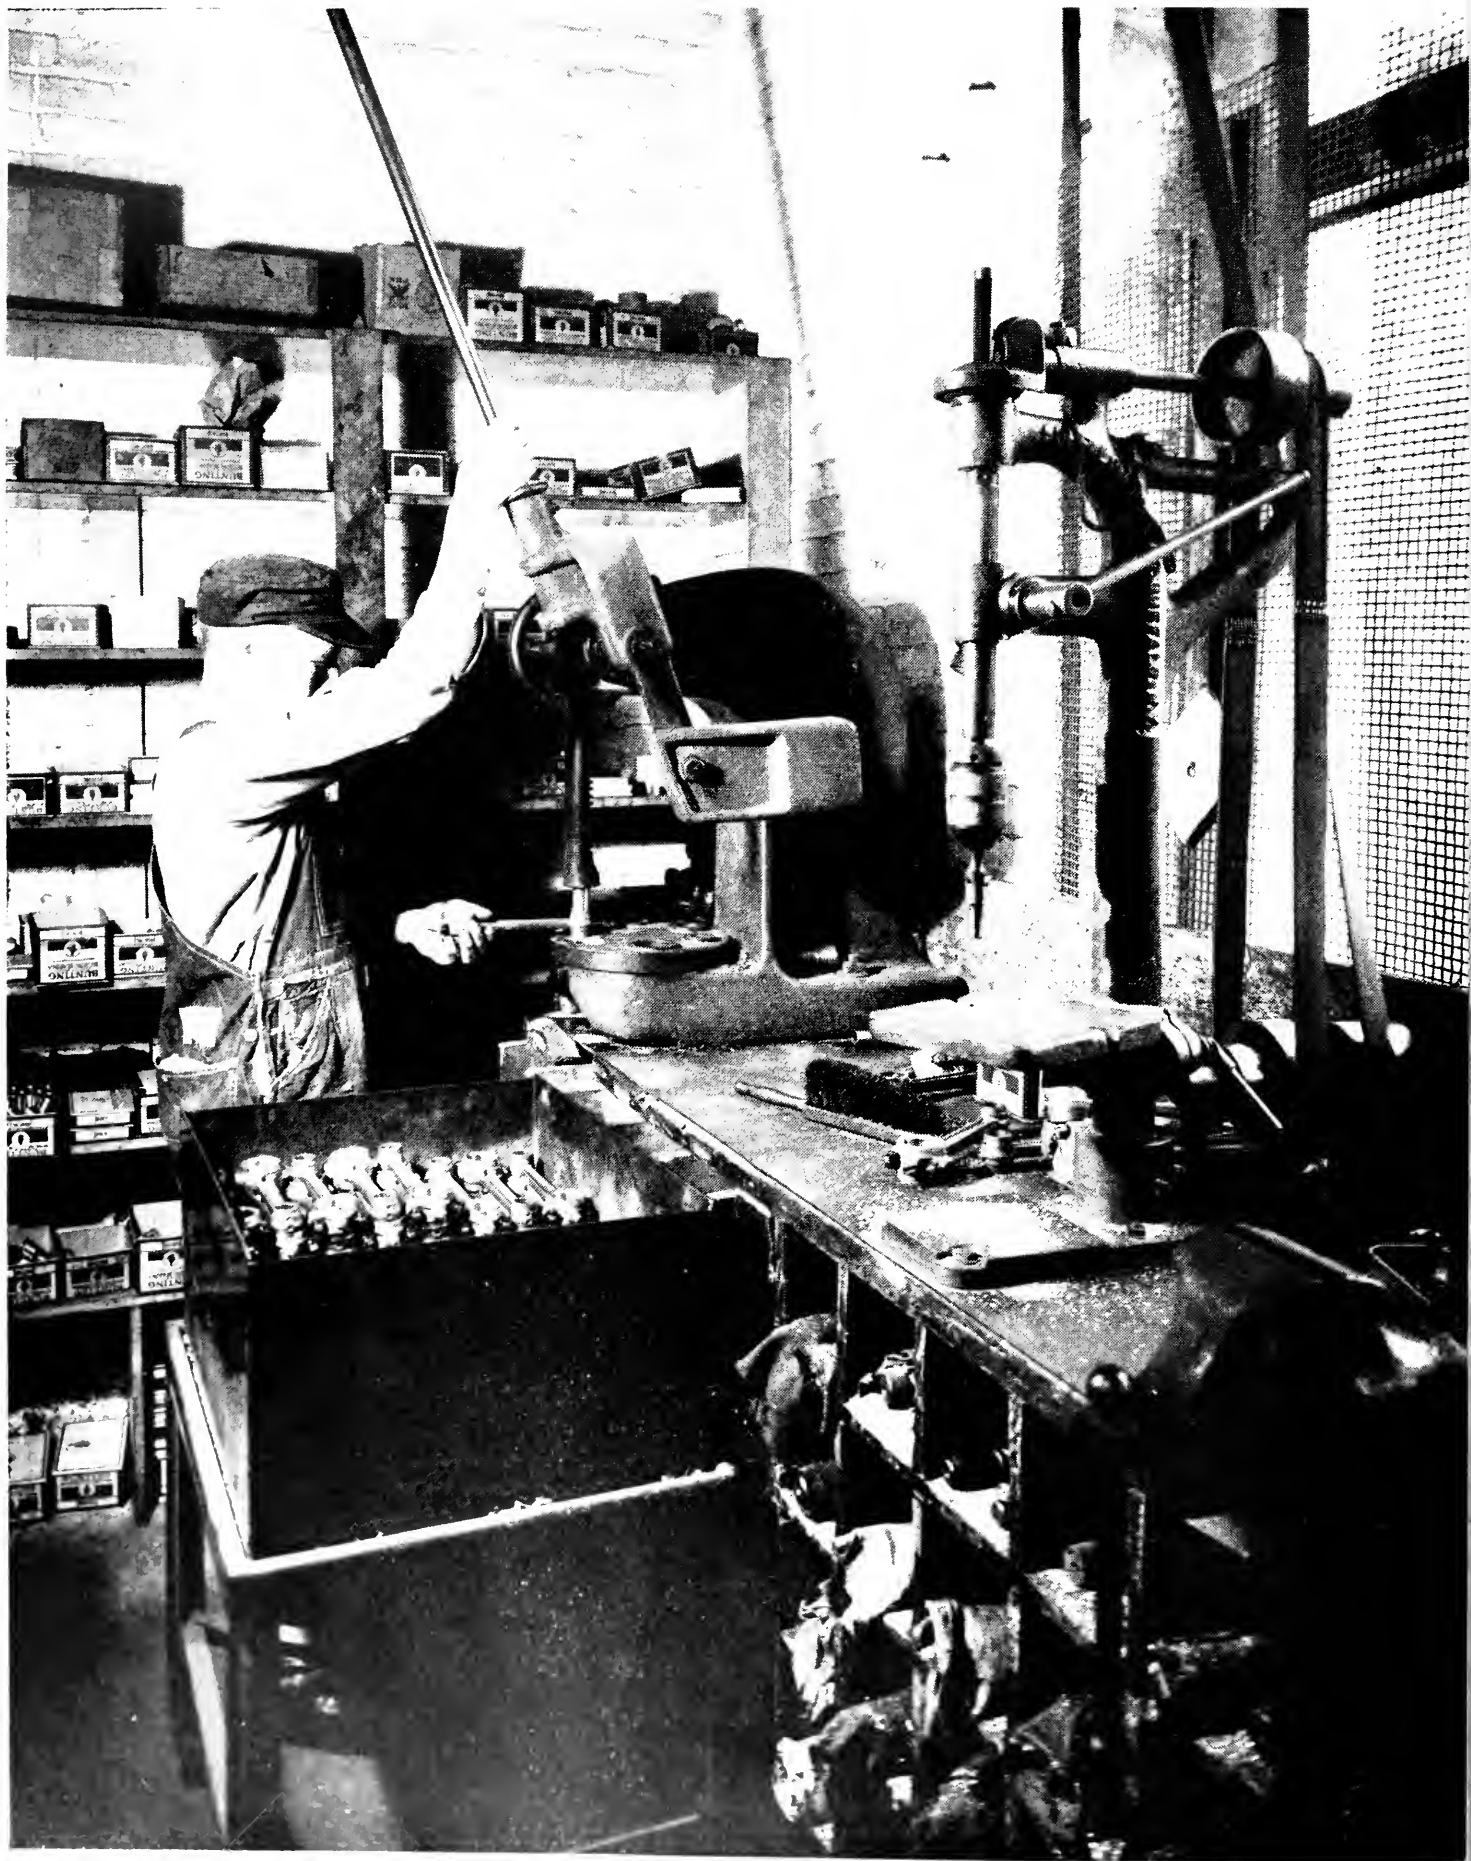
PLAINTIFF'S EXHIBIT No. 26

About one half of the connecting rods rebabbitted require new bushings in small end of the shank. These are installed by a hand operated arbor press, as shown above.

Model A Ford connecting rods are fitted with a very thin bushing which becomes somewhat damaged and burred when being pressed in by the arbor press shown in Picture 26. This is corrected by placing the connecting rods in a bench drill press in which a chamfering tool is used as shown in the above picture.

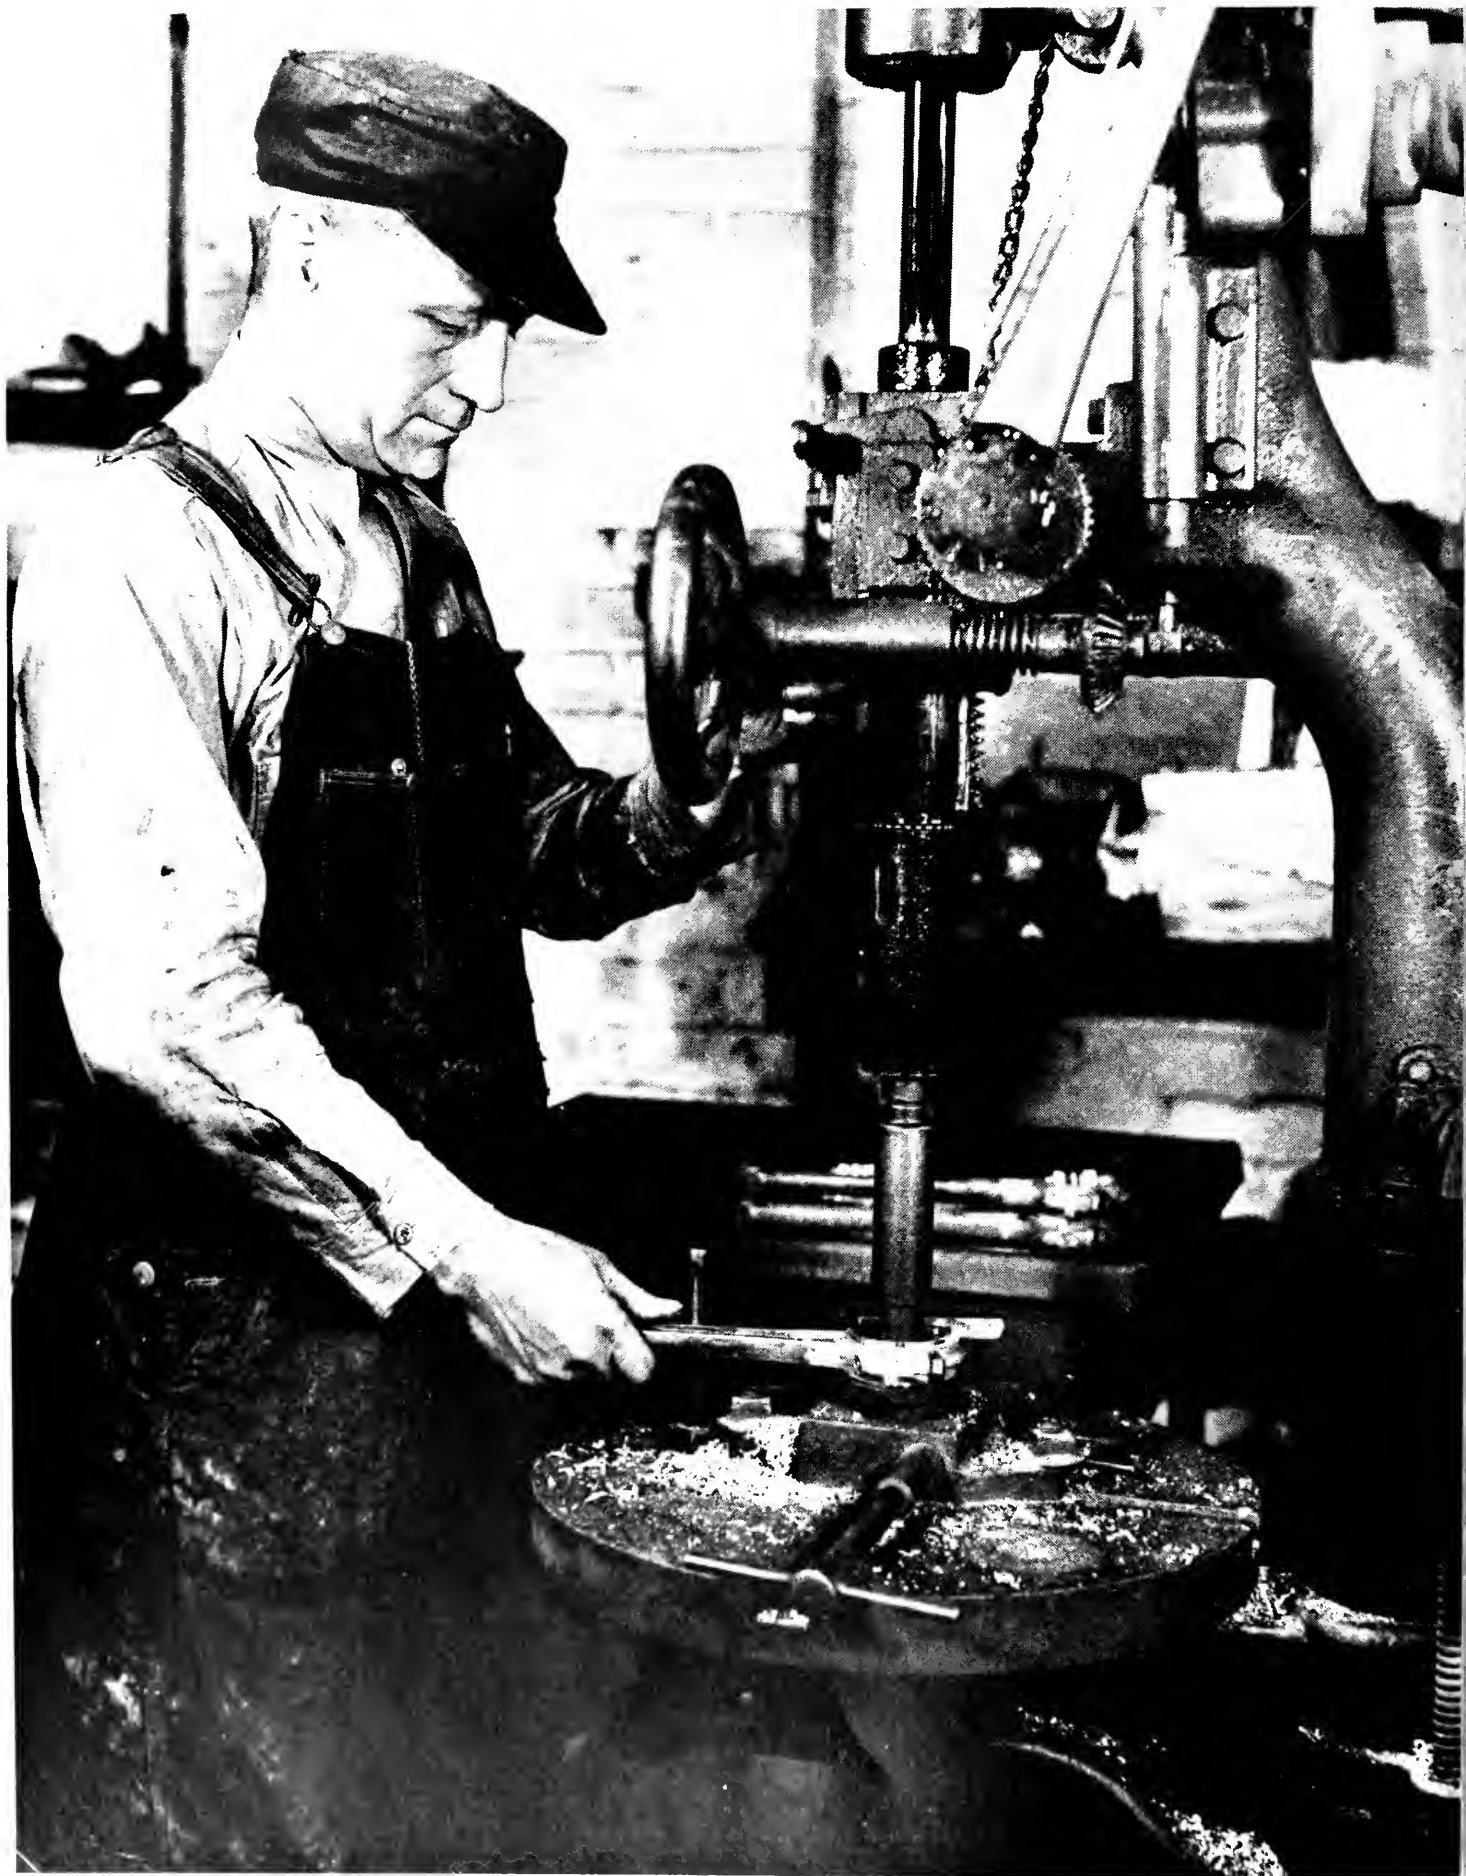
PLAINTIFF'S EXHIBIT No. 27

The outer edge of the babbitt flange is now faced by a special tool placed in a drill press. Approximately 50% of the rods re-babbitted were of a type that required this operation, which is shown in the above picture.
